Glen Garioch Distillery – Sub Cooler Scale Remover

Client: Beam Suntory

Location: Glen Garioch Distillery

Services: Chemical Cleaning

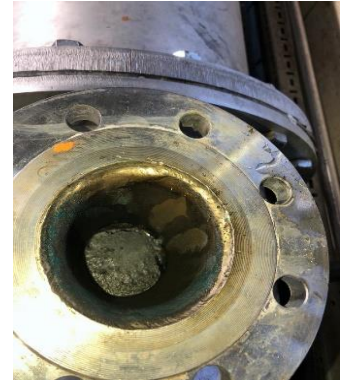
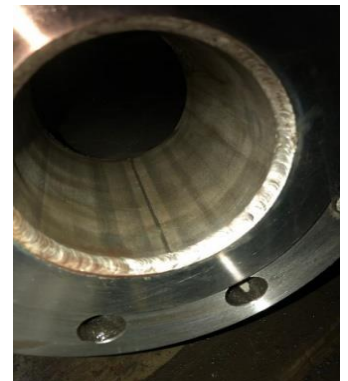
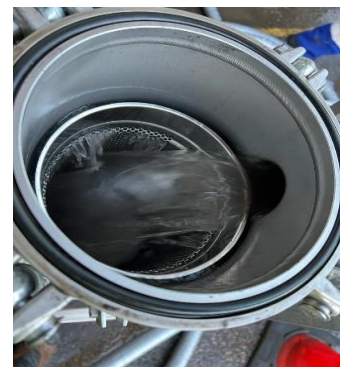
- Saturn were approached to remove fouling that was amassing on a heat exchanger being used to cool down whisky distillate at Glen Garioch Distillery.
- We were tasked to create a procedure that would remove the contaminate from the system in a safe and effective manner. As the restart of production was planned to commence on completion of the chemical clean, Saturn were required to complete the job quickly while avoiding delays.
- Saturn aimed to work to the health and safety guidelines and expectations set by the client in addition to Saturn’s own high standard procedures.

- The fouling on the inside wall of the distillate pipe was removed allowing for greater heat transfer from the cooling water.
- The temperature of the distillate passing through the sub-cooler decreased below 20°C after the chemical clean, “massively” increasing the systems efficiency.
- All work was completed incident free and on time.

- Saturn mobilised both personnel and equipment on site quickly. Production downtime was minimised by completing the clean on time therefore allowing the distillery to get back into production more quickly.
- Due to the system being in poorer condition than expected, Saturn’s enhanced procedure and solution allowed the flexibility to adjust the process to enable the removal of heavier contamination than first anticipated.
- Saturn’s Beer Stone chemical solution and process provided better cleaning results when compared to those of contractors previously used by Beam Suntory.
- By using less equipment a rapid turnaround was achieved thanks to quick installation of the temporary equipment and a rapid clean up.
- Bespoke solutions and flexibility enhanced performance and turnaround.
